## Section VI North Smyrna Elementary School

### Overview – NES

| Address: | 365 North Main Street, Smyrna, Delaware 19977 |

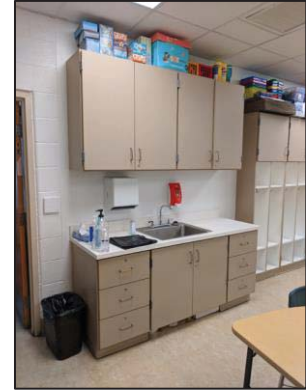
Vertical and horizontal circulation are not significant problems in this 1-story school. Recent modifications have addressed the most critical issues concerning access to restrooms and the stage area. Several remaining toilet rooms require modification or replacement of existing stall configurations. Casework in classrooms, including sinks, are worn and not accessible. These areas should be replaced with new, compliant items. Various other minor accessibility issues require correction in order to be fully inclusive. This includes items like replacing non-compliant drinking fountains, and installing undersink insulation or grab bars.

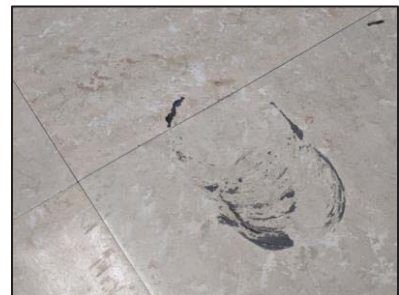
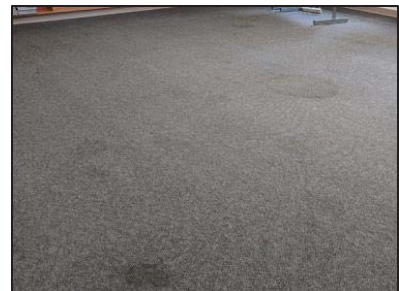
The majority of resilient floor finishes throughout the building are in acceptable condition. Occasional areas of damage or cracking should be corrected. Base trims, however, are worn, damaged, and dated in color (see Walls below for more information). Areas of carpet in Wings A and C-D are worn, stained, and damaged. They are past their expected service life, and should be replaced with new carpet and resilient base trim.

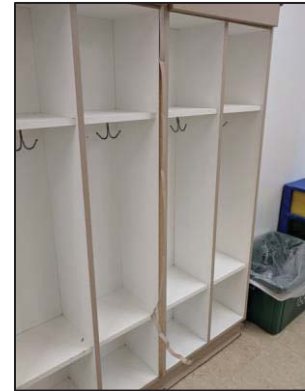
Casework (cabinets, countertops, and shelving) is worn and damaged. Most rooms are still serviceable. Selected areas of damaged casework in Wing A and throughout Wing B should be repaired or replaced in kind. See also Accessibility segment above for non-compliant casework modifications.

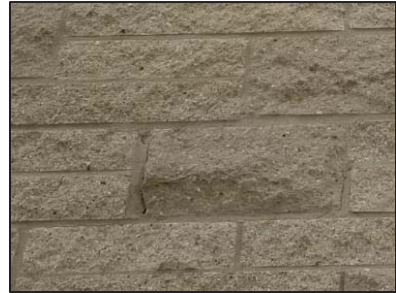
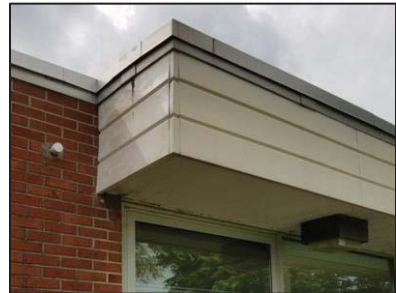
The existing brick / CMU walls are in good condition. Cracking and settlement are mostly confined to Wings A / B. At a minimum, the cracks require repair and repointing.

Exterior metal siding and soffit panels on Wings A, C, and D are aged, deteriorating, and have been previously painted. Paint is peeling and mildewed. These should be replaced with new prefinished metal wall panels and soffits to match 2005 addition and provide a coherent exterior appearance.

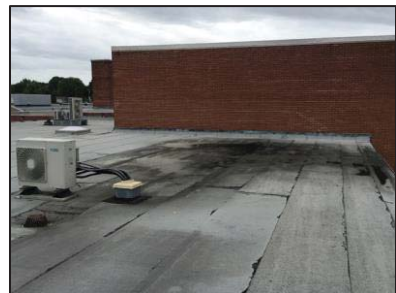
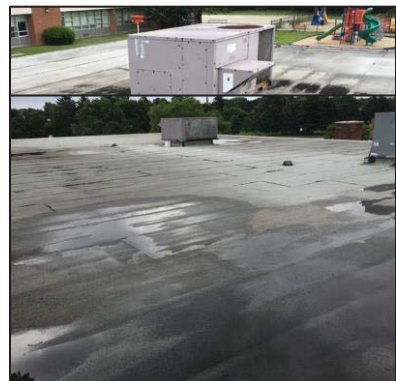
Original built-up roofs were replaced by a modified bitumen roof (MBR) system in approximately 2002. These in turn have reached the end of their expected service life and should be replaced within the next year if possible.

Deteriorated insulation and flashings were observed throughout. Ponding is a major problem in most places, and evidence of water infiltration is visible in various interior locations. Timely roof replacement is critical to avoid the expense of additional interior water damage. As part of this program, existing cast stone copings should be covered with new prefinished aluminum copings to improve water integrity of the roof / exterior wall connection. During roof

replacement, the District should strongly consider installing additional insulation depth where feasible rather than simply replacing in kind.

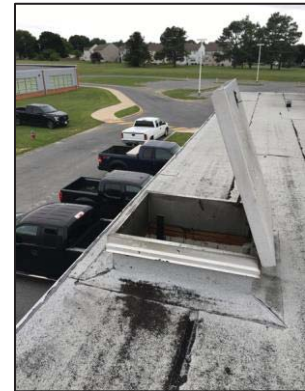
The roof access hatch is located immediately adjacent to the exterior wall and opens directly onto a significant sheer drop. This is a critical safety hazard and is not code compliant. A wall-mounted guard rail must be installed to provide fall protection for personnel using the hatch.
