SMYRNA *Middle School*

Certificate of Necessity

Gipe Associates, Inc.
CONSULTING ENGINEERS

Project No.: 18047
August 09, 2019

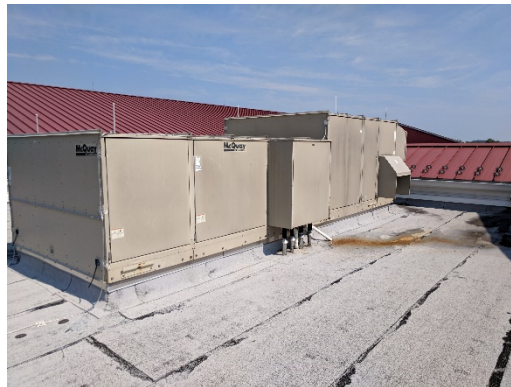
Photograph 1: ERU-5 on Roof

- During the site survey ERU-5 serving the cafeteria (see Photograph 1) was noticeably loud, the noise was characteristic of a worn fan motor bearing or shaft (likely the exhaust fan). The unit should be serviced and inspected for any additional damage.

1 - ERU-5 FAN MOTOR REPAIR	QUANTITY		MATERIAL		LABOR		TOTAL COST
	NO. OF UNITS	UNIT OF MEASURE	PER UNIT	TOTAL	PER UNIT	TOTAL

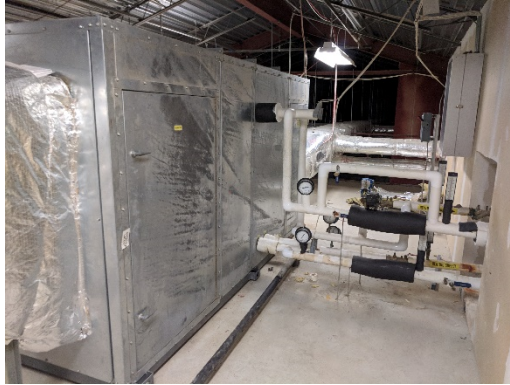
Photograph 2: ERU-2 in Mechanical Mezzanine

- ERU-1 (labeled ERU-A in the BAS) has had chronic problems with coils cracking and leaking after multiple repairs and a full coil replacement. This points to a possible system design flaw that needs investigation before replacing ERU-1 and ERU-2 (see Photograph 2).

2 - ERU-1/2 STUDY AND REPLACEMENT	QUANTITY		MATERIAL		LABOR		TOTAL COST
	NO. OF UNITS	UNIT OF MEASURE	PER UNIT	TOTAL	PER UNIT	TOTAL

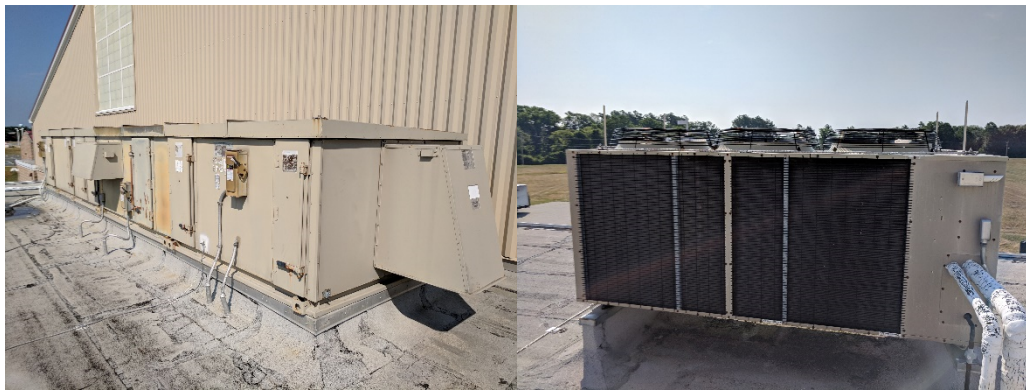
Photograph 3: Typical Rooftop Unit Split System

- All RTU's original to the building should be replaced. Two of the units are converted DX Split Systems, RTU-2/CU-2A (see Photograph 3) and RTU-7/CU-7. The unit casing's and disconnect switches are rusted and CU-2A condensing fans are vibrating excessively. Further, the systems are charged with R-22, a refrigerant that the EPA is phasing out and will be illegal to produce in 2020. These units should be replaced with packaged DX units.

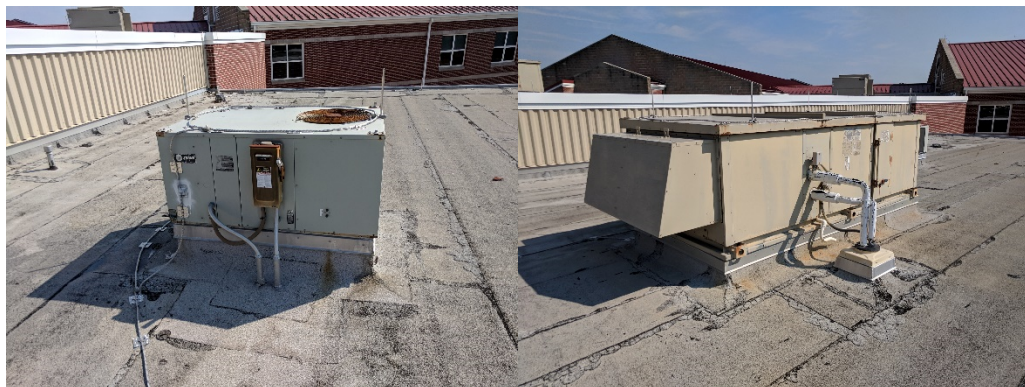
Photograph 4: Typical RTUs on Roof

The remaining 4-pipe RTU's (see Photograph 4) are similarly rusted and in poor condition. RTU-6 is slated to be replaced this summer but it is suggested that all units (RTU-1 thru 9) be replaced before they begin to fail and require extensive repair.

3 - (7) RTU REPLACEMENTS	QUANTITY		MATERIAL		LABOR		TOTAL COST
	NO. OF UNITS	UNIT OF MEASURE	PER UNIT	TOTAL	PER UNIT	TOTAL

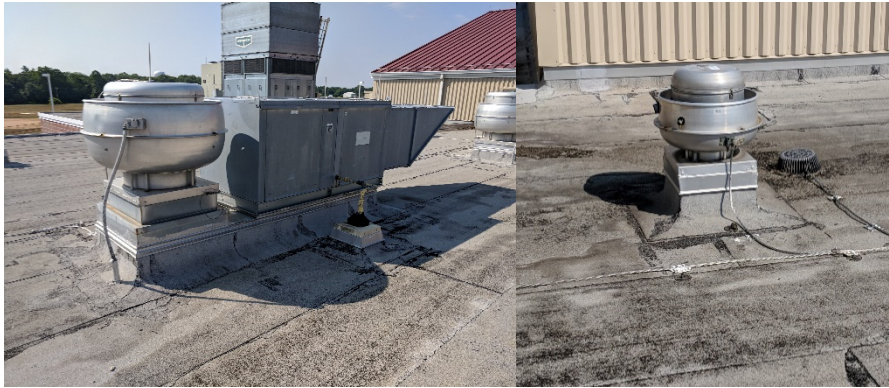
Photograph 5: Typical Make Up Air Unit and Dishwasher Exhaust Fan

- The Kitchen make up air units (KSU-1/KSU-2) and dishwasher exhaust fan EF-3 have had maintenance issues in the past and are in poor condition. These systems are original to the building and need to be replaced.

4 - KITCHEN HVAC SYSTEM REPLACEMENT	QUANTITY		MATERIAL		LABOR		TOTAL COST
	NO. OF UNITS	UNIT OF MEASURE	PER UNIT	TOTAL	PER UNIT	TOTAL

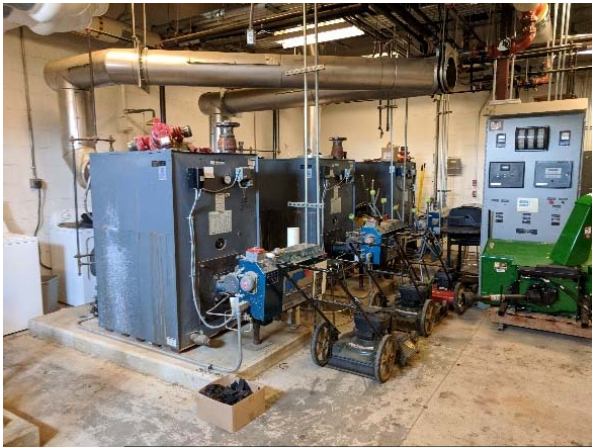
Photo #7 Abandoned Boilers

The original Boilers, Air-Cooled Chiller and Closed Circuit Cooler have been abandoned in place. It is recommended that these units be removed before they begin deteriorating and become a safety risk. These units may still be useful to the Smyrna School District if they can replace older systems currently in use in other buildings, however a further more detailed assessment would be needed to ensure these units are fit for refurbishment and reuse.

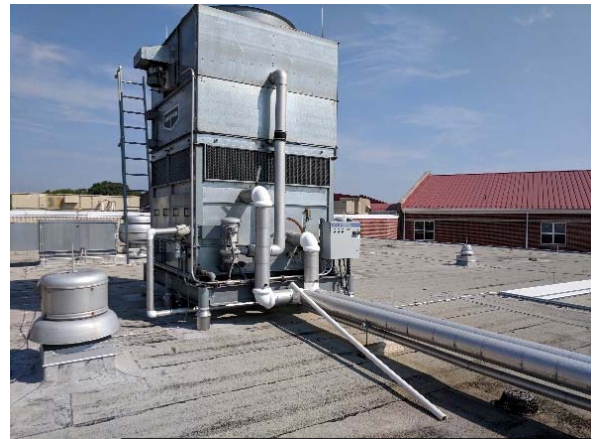
Photo #14 Abandoned Closed Circuit Cooler

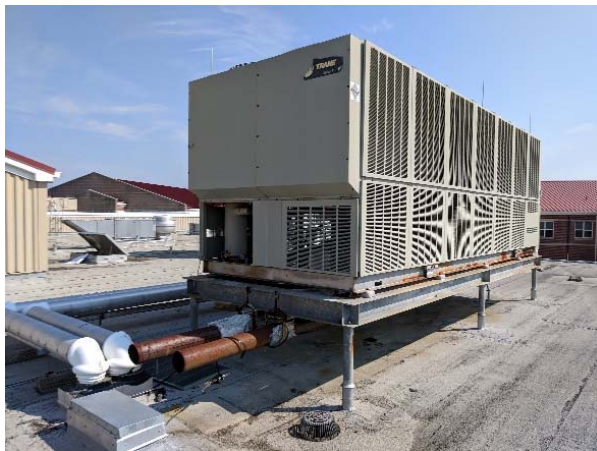
Photo #19 Abandoned Air Cooled Chiller

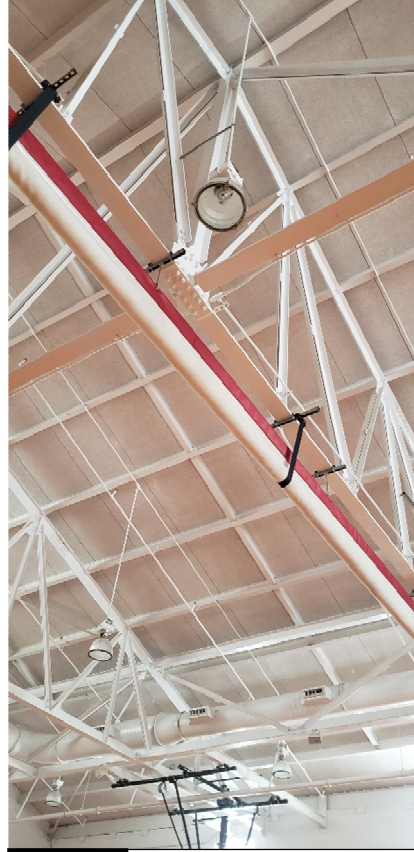
While the lighting systems are not in immediate need of replacement, as part of general improvements to the building, changing from fluorescent and metal halide light sources to LED light sources would result in energy savings. During our walk-through of the building it was noted that a couple of the Metal Halide (MH) pendant gym lights have been replaced with LED pendant gym lights as the MH lights need replacement. Some of the exterior lights are beginning to show signs of wear due to the weather and will probably need to start being replaced within the next 4-5 years. Installing lighting controls such as occupancy sensors in the classrooms throughout the building could also increase energy savings as the current building does not have an automatic means to turn off the lights in that space when that space is unoccupied. It was noted that occupancy sensors had been installed in the bathrooms, but not in other areas of the building. The current lighting controls do not comply with the current edition of ASHRAE 90.1. Routine and periodic maintenance of the lighting system is recommended.

Photo #10 Gym Light with Metal Halide Lamp

- Replace interior and exterior lighting with LED fixtures
- Provide lighting controls throughout the building to automatically turn lights off in spaces that are empty.

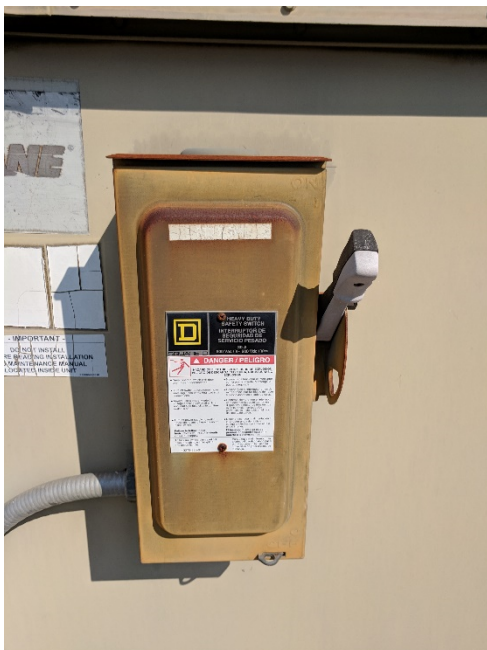
There are no immediate or significant repairs that need to be made to the building receptacles. Many of the exterior disconnects are showing signs of rusting, so we would recommend that new NEMA 4X, stainless steel disconnects be provided for all exterior HVAC equipment that is replaced. The technology department has some planned improvements for buildings special systems as outlined below in the planned improvements section of this report.

Photo #11 Exterior Disconnect Switch that needs to be replaced

- Replace exterior disconnect switches for all exterior HVAC units that are replaced.

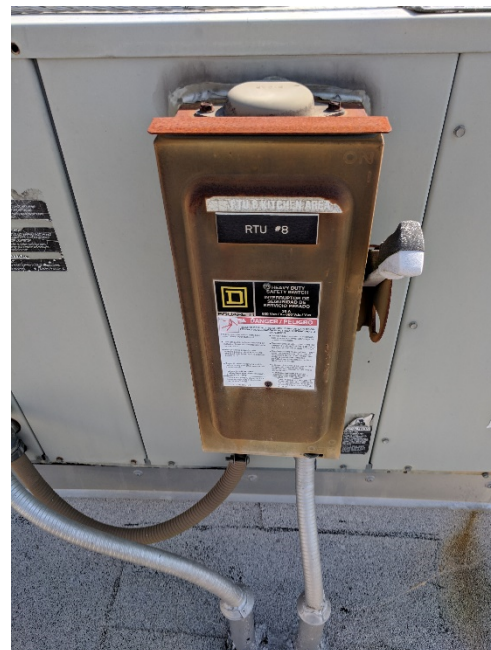
Photo #12 Exterior Disconnect Switch that needs to be replaced
