CN / REFERENDUM SUPPORT ASSESSMENT

August 2019

Fearn Clendaniel Architects Inc

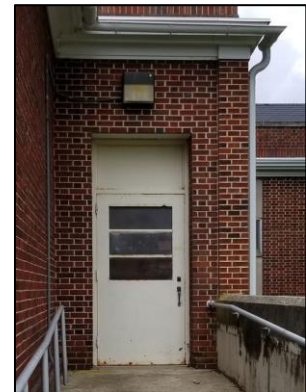
Exterior doors / frames (mostly hollow metal or metal-clad insulated core), and hardware are aged and wearing. All require paint in the near future to prevent further weathering. Some exterior doors are rusting out or damaged and should be replaced in the moderate future.

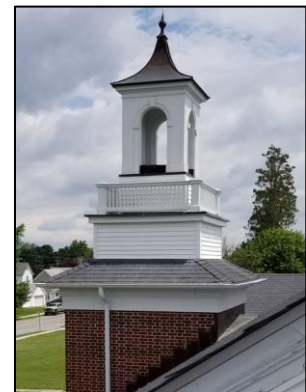
Exterior Wood Cupola

The existing wood cupola structure is subject to continual weathering. While it is structurally sound and fundamentally in good condition, it is maintenance-intensive and requires regular painting and other upkeep. This will keep the cupola, railings, and other items in service for the moderate future. As part of a long term plan, the

District should consider future replacement with weatherproof construction, such as fiberglass or aluminum.

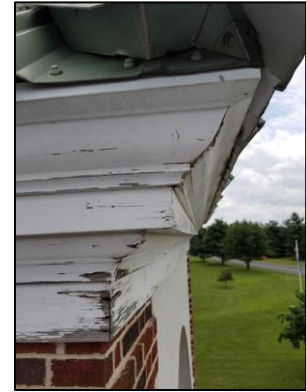
The existing wood cornices and other trims on older parts of the building are subject to continual weathering and maintenance-intensive. Numerous areas are showing signs of rot and water infiltration. In the near term, this requires painting to prevent further deterioration. If funding is available, we recommend this trim should be clad with or replaced by prefinished aluminum trims. Cost will vary by size and complexity of the trim profile.

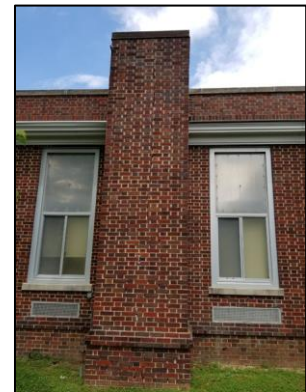
The existing brick walls are in good to fair condition throughout the building, despite the age of older portions. Cracking and settlement are minimal and localized. Some weathering of mortar joints has occurred, particularly around stone windowsills. A program of masonry cleaning and repointing in the mid-term future will help preserve strength and appearance. One item requires priority attention: an existing chimney on the east of B wing shows significant cracking. At a minimum, the cracks require repair and repointing. This chimney is believed to be abandoned and could be demolished to eliminate future problems.

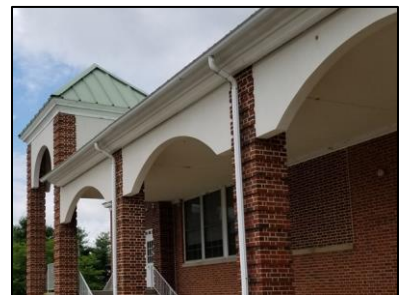
Finishes at the existing soffit ceilings at the main entrance canopy and other door / entry locations are weathered. Repaint / refinish these areas for proper appearance and to prevent deterioration.

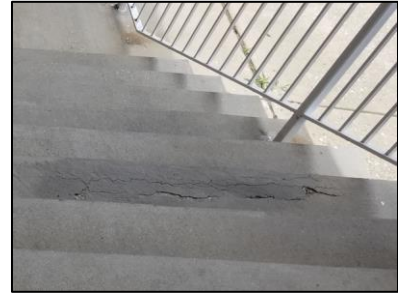
Existing concrete walk areas are in generally good to fair condition. Regular maintenance with replacement of individual sections as necessary will keep them in service. On the exterior of A Wing, cracks in the accessibility ramp and main entrance stairs should be corrected before further damage occurs.

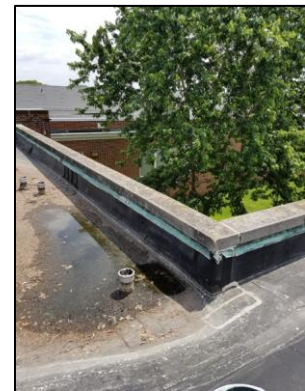
Original built-up roofs were replaced by EPDM membrane roof systems in the early 1990s. These in turn have reached the end of their expected service life and should be replaced within the next 3-4 years. Areas of delamination and deteriorated flashings were observed throughout low-slope areas. Ponding is a problem in some places. Timely roof replacement is critical to avoid the expense of additional interior water damage. As part of this program, remaining cast stone copings should be covered with new prefinished aluminum copings to improve water integrity of the roof / exterior wall connection.

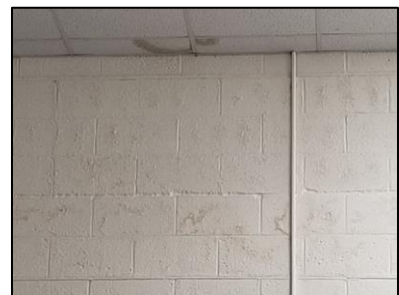
Walls in offices, work areas, and corridors are predominantly painted or glazed masonry. Some cracking was observed in varying areas, and should be repaired. There is also evidence

of water penetration in the Large Training Room 116. Once that situation is resolved, the affected walls will require cleaning, preparation, and repainting.

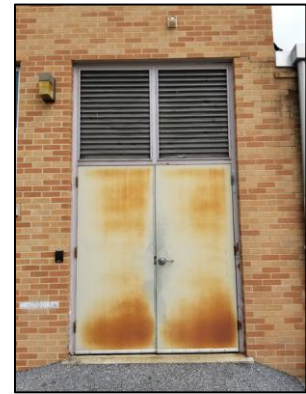
Exterior hollow metal doors / frames and hardware are aged. All require paint in the near future to prevent further weathering. Some exterior doors are rusting or damaged and should be replaced in the near future. Storefront at main building entrance is in very good condition and needs only routine maintenance.

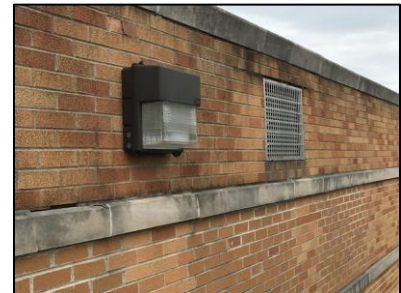
The existing brick / CMU walls are in fair to poor condition throughout the building. Cracking and settlement has occurred in several areas and requires repair. Extensive weathering of mortar joints has occurred, particularly around stone copings and windowsills. Walls show evidence of chronic wetness around downspout and overflow locations. A program of masonry cleaning and repointing in the mid-term future will help preserve strength and appearance.

Of particular concern is the upper stone trim around the Large Training Room 116 (*image above*). Mortar and sealant joints at this trim have eroded almost completely, exposing structural steel to the weather and creating numerous water infiltration points. Evidence of water infiltration is visible inside this room. This area requires immediate attention.

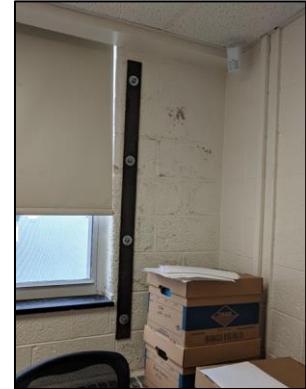
Another area showing problems is the exterior corner of Office 109, with substantial cracking. This has been stabilized with through-bolted steel sandwich plates, but requires permanent structural correction.

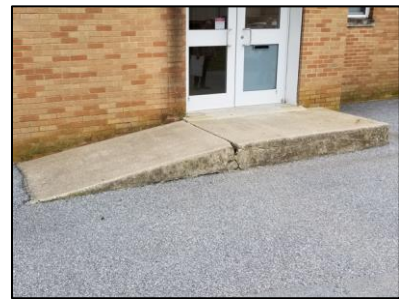
Walks are minimal on site, but landings and ramps at each exterior door are in generally poor condition. Although the main entrance is ADA compliant, most other doors are not. Considering their poor condition, these landings and adjoining ramps should be replaced with accessible, ADA-compliant features.

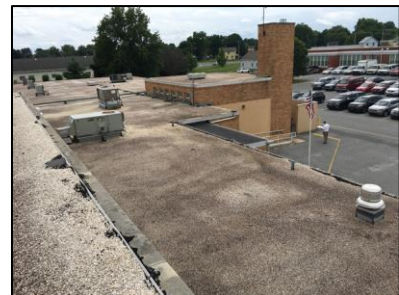
Gravel-ballasted built-up roofs across the building may be original, and have exceeded their expected service life. Drains and scuppers show evidence of chronic water overflow onto walls below. Ballast / topping erosion and deteriorated flashings were observed throughout low-slope areas. Ponding is a problem in some places. To avoid the expense of additional water damage, both interior and exterior, all roofs should be replaced within the next 3-4 years, or earlier if feasible. Timely roof replacement is critical. As part of this program, all metal roof edge trims, scuppers, and downspouts should be replaced. Remaining cast stone copings should be covered with new prefinished aluminum trim to improve water integrity of the roof / exterior wall connection.

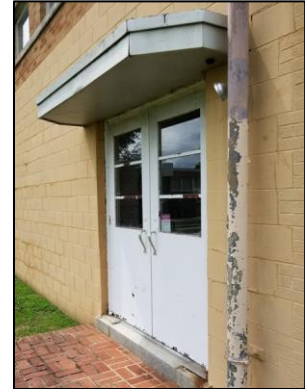
Exterior canopy roofs and related structures at Large Training Room 116 are deteriorated. These canopies should be demolished and replaced with similar construction.

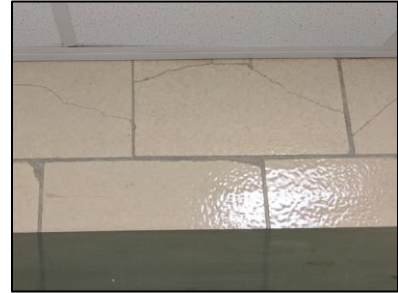
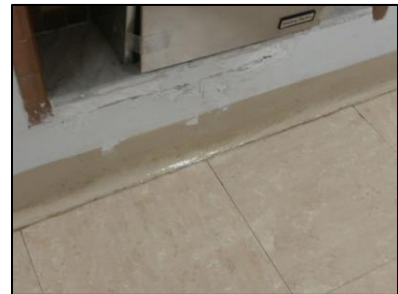
Walls in offices, work areas, and classrooms are predominantly painted plaster of gypsum wallboard. Cracking and damage was observed in varying areas, and should be repaired. Masonry and glazed masonry walls in high traffic areas show cracking and damage. Where repair is possible it should be performed. Where repair is not feasible, regular inspection is necessary to monitor future deterioration.

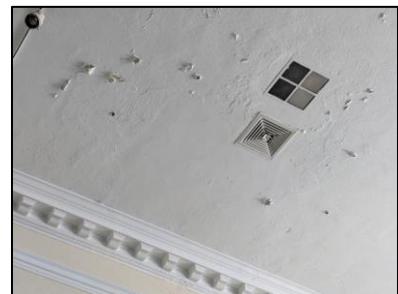
Plaster ceilings throughout the 2nd floor area show moisture and other damage. These require repair to avoid further deterioration, and repainting throughout. Localized areas throughout the building show evidence of minor water infiltration or leaks in acoustical panel or other ceilings. These must be investigated by District personnel, the water sources corrected as required, and damaged materials replaced.

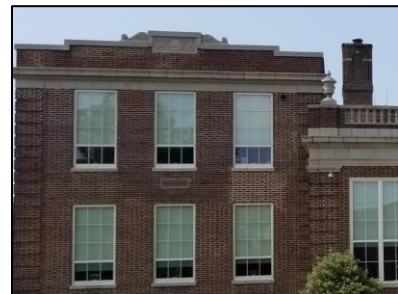
The existing brick / masonry walls are in generally sound condition. However, at more than 100 years old, brick in certain areas is showing surface erosion. Limestone trim is weathering as well. These items will require routine

inspection and care. A program of masonry preservation in the long-term future will help preserve strength and appearance.

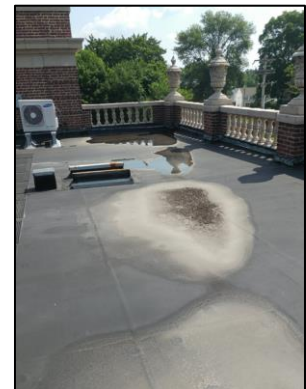
At this point in the building's history, all original roofs have been replaced with EPDM membrane systems throughout low-slope areas. Although still within expected service life, some of these replacements show signs of age or imperfect workmanship. Older areas show numerous wrinkles, delaminations, or raised fasteners. Ponding is a problem in some places. Flashings, both metal and membrane, require attention. In particular, vertical membrane flashings were installed to cover and protect weathered brick parapets. Many of these are beginning to un-adhere and delaminate from the substrate. These should be repaired or reinstalled with additional fastenings and termination bars.

Membrane roofs will require a replacement program in the long-term future as older replacements reach the end of their own service cycles. This is expected to begin approximately 8-10 years from date of this writing.

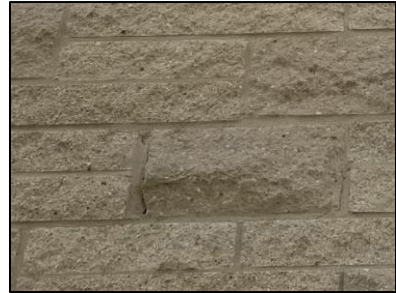
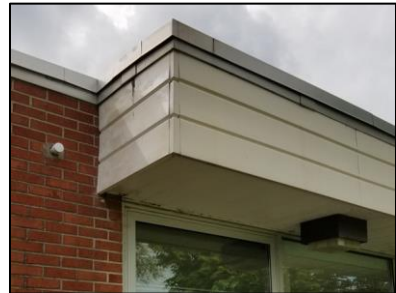
Exterior metal siding and soffit panels on Wings A, C, and D are aged, deteriorating, and have been previously painted. Paint is peeling and mildewed. These should be replaced with new prefinished metal wall panels and soffits to match 2005 addition and provide a coherent exterior appearance.

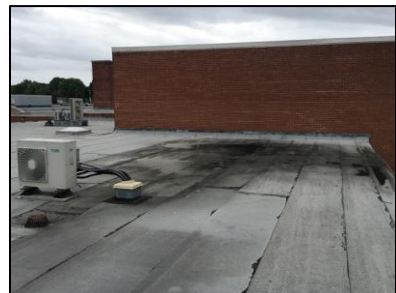
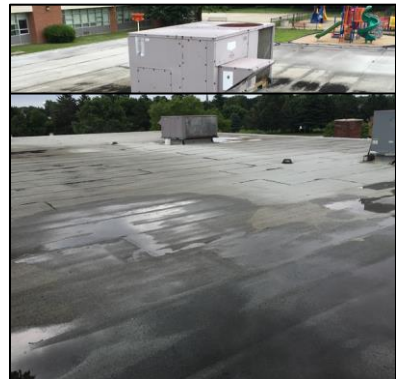
Deteriorated insulation and flashings were observed throughout. Ponding is a major problem in most places, and evidence of water infiltration is visible in various interior locations. Timely roof replacement is critical to avoid the expense of additional interior water damage. As part of this program, existing cast stone copings should be covered with new prefinished aluminum copings to improve water integrity of the roof / exterior wall connection. During roof

replacement, the District should strongly consider installing additional insulation depth where feasible rather than simply replacing in kind.

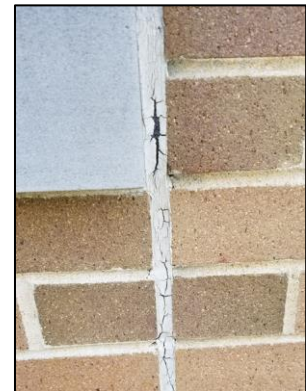
Sealant joints at most stone window sills and masonry control joints are failing and should be replaced as part of a routine exterior maintenance program.
