# SUNNYSIDE

*Elementary School*

## *Certificate of Necessity*

*Project No.: 18047*  
*August 09, 2019*

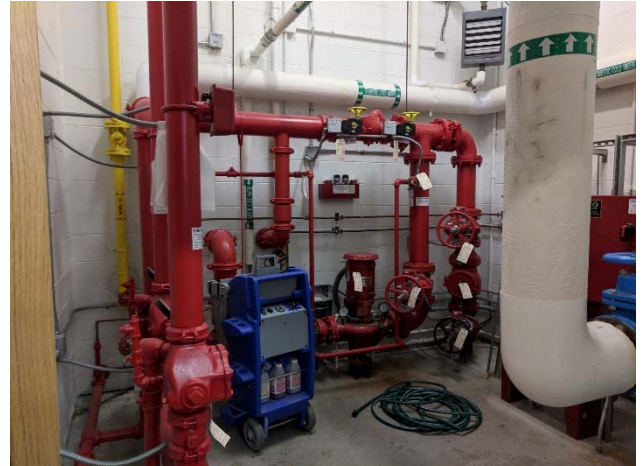
Photo #2 Domestic and Fire Protection Water Entrances

- Copper domestic piping is prone to corrosion due to water chemistry in Smyrna. Other schools in the district have experienced this and replaced piping with Uponor PEX (cross-linked polyethylene). It is recommended that the Middle School do the same. Domestic water piping needs replacement in all areas except the Kitchen and 'A' Wing.

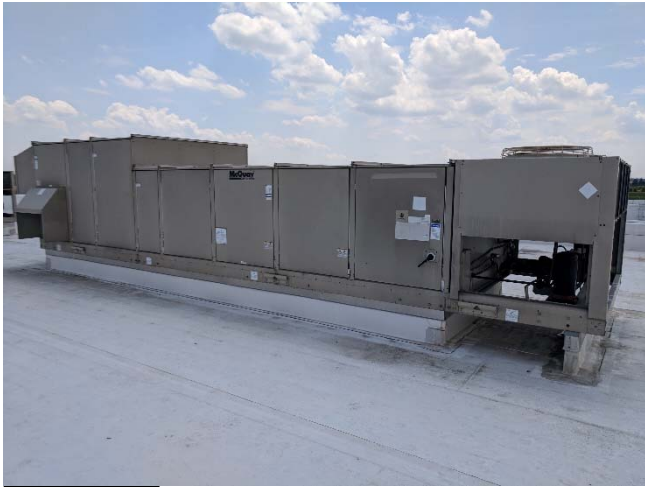
Photo #9 Typical Packaged RTU with Energy Recovery

The packaged controllers for the RTUs do not effectively interface with the supervisory ATC system. We recommend replacing the control boards and reprogramming the units to increase compatibility with the control system.

All RTUs utilize R-22, which will be phased out by the EPA in 2020. It is recommended that the units be replaced or modified in order to utilize refrigerants more widely available.

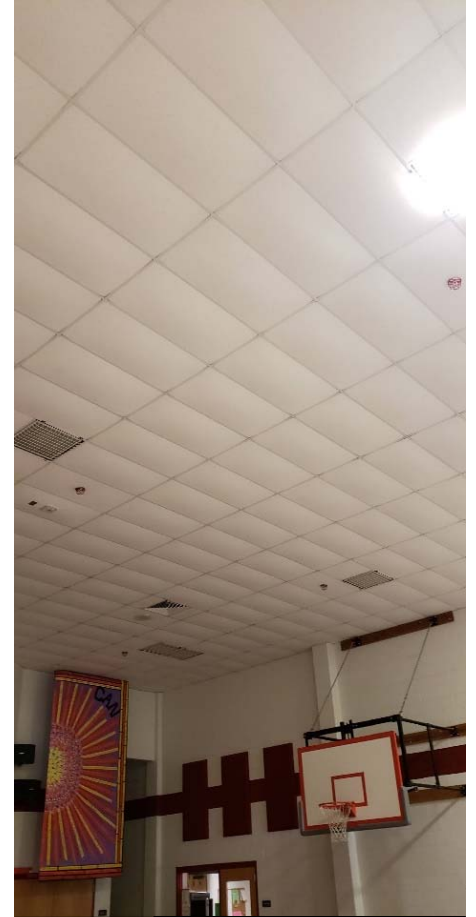
Photo #7  
Lights and Ceiling in Gym/Auditorium/Cafe

While the lighting systems are not in immediate need of replacement, as part of general improvements to the building, changing from fluorescent and metal halide light sources to LED light sources would result in energy savings. Installing lighting controls such as occupancy sensors in the classrooms throughout the building could also increase energy savings as the current building does not have an automatic means to turn off the lights in that space when that space is unoccupied. The current lighting controls do not comply with the current edition of ASHRAE 90.1. Routine and periodic maintenance of the lighting system is recommended.

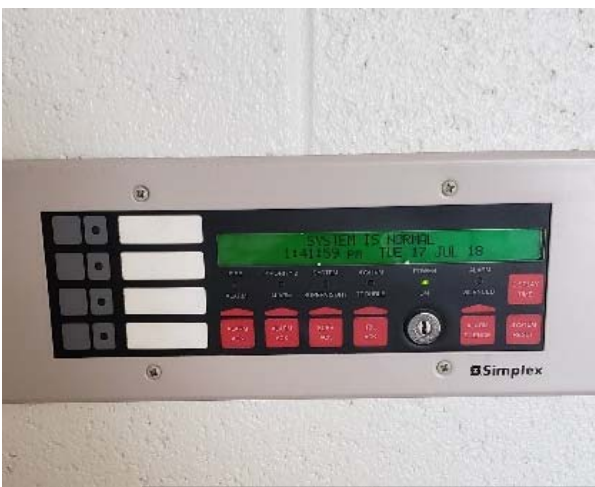
Photo #8  
Fire Alarm Annunciator Panel

There are no immediate or significant repairs that need to be made to the building fire alarm system. Routine and periodic testing and maintenance of the fire alarm system is recommended. While the existing fire alarm is in good condition, it utilizes audible horns and visual strobe notification devices and does not have a voice evacuation system. The 2015 NFPA 101 Life Safety Code requires that any new schools with 100 or more occupants have a fire alarm system utilize an emergency voice/alarm communications system to notify occupants. Even though a change is not required now, if a major renovation was to occur to the existing school, then the existing fire alarm system would need to be upgraded to a voice evacuation system.
