## Section VI North Smyrna Elementary School

### Overview – NES

| Address: | 365 North Main Street, Smyrna, Delaware 19977 |

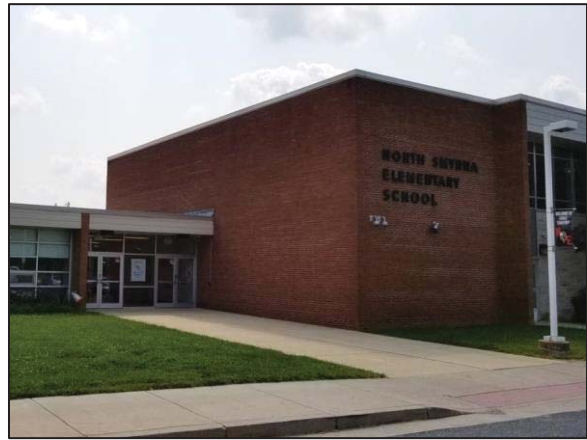
North Smyrna Elementary School is a single-story 1960s building with classroom additions attached to the rear via a long breezeway. The original central building houses common areas and administration, with the original classroom wing extending to the east. The exterior envelope is predominantly brick with large aluminum storefront windows. In general, masonry is in good condition, but metal wall panels and soffits are aging. Windows and exterior doors are mostly serviceable throughout.
