SMYRNA *Middle School*

Certificate of Necessity

Gipe Associates, Inc.
CONSULTING ENGINEERS

Project No.: 18047
August 09, 2019

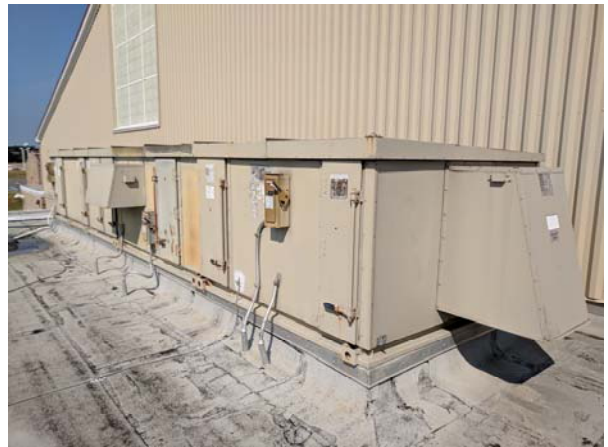
Photo #26 ERU-2

- ERU-1 (labeled ERU-A in the BAS) has had chronic problems with coils cracking and leaking after multiple repairs and a full coil replacement. This points to a possible system design flaw that needs investigation before replacing ERU-1 and ERU-2 (see Photograph 2).

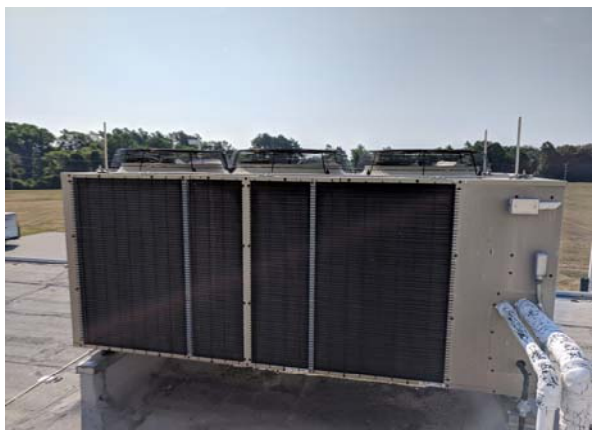
Photo #27 CU-2a Typical Split DX Outdoor Condensing Unit

- All RTU's original to the building should be replaced. Two of the units are converted DX Split Systems, RTU-2/CU-2A (see Photograph 3) and RTU-7/CU-7. The unit casing's and disconnect switches are rusted and CU-2A condensing fans are vibrating excessively. Further, the systems are charged with R-22, a refrigerant that the EPA is phasing out and will be illegal to produce in 2020. These units should be replaced with packaged DX units.

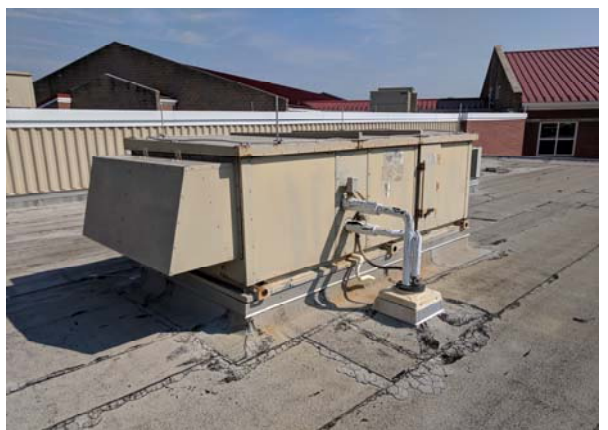
Photo #28 Typical 4-Pipe RTU

The remaining 4-pipe RTU's (see Photograph 4) are similarly rusted and in poor condition. RTU-6 is slated to be replaced this summer but it is suggested that all units (RTU-1 thru 9) be replaced before they begin to fail and require extensive repair.

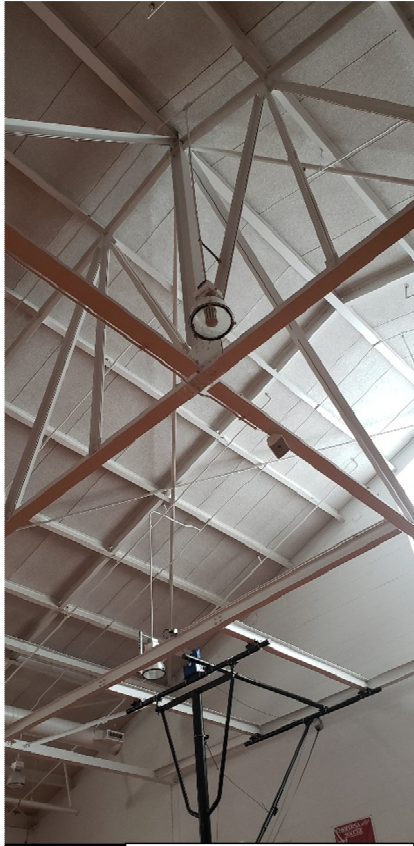
Photo #9 Gym Light Replaced with LED lamp
