CN / REFERENDUM SUPPORT ASSESSMENT

August 2019

Fearn Clendaniel Architects Inc

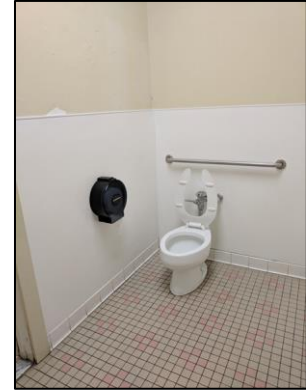
In general, accessibility is not a major problem, despite the school's age. Various minor accessibility issues require correction in order to be fully inclusive. This includes items like replacing non-compliant drinking fountains and sinks, installing undersink insulation or grab bars, and replacing door hardware with lever-style units.

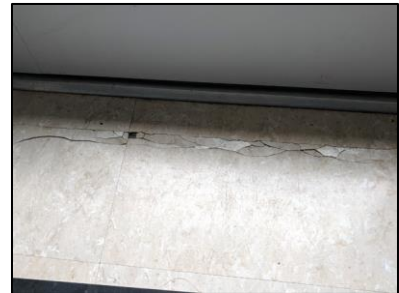
The majority of the floor finishes and base trims throughout the building are worn and dated. Classroom areas in the A Wing have been replaced recently (2016), and those in the B Wing extension are newer and remain in acceptable condition. The balance of the building should have a comprehensive floor finish replacement, including resilient tile, carpet, and resilient base trim.

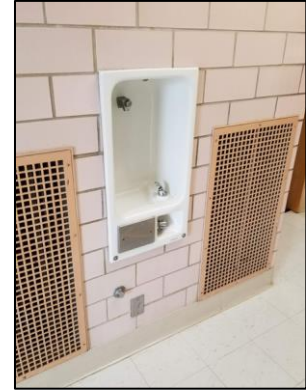
The building is generally accessible, comprising a single story. Ground floor elevation is relatively near grade level. Several ramps offer access to the building, though these vary in condition and compliance and should be replaced as priority indicates. Due to the date of original construction, some interior elements such as doorways are non-compliant. Various accessibility issues require correction in order to be fully inclusive. These include items like replacing non-compliant drinking fountains and sinks, and installing undersink insulation or grab bars.

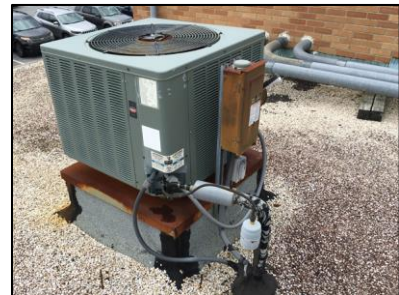
Detailed information concerning mechanical systems is included in a separate report. However, simply due to age, the administration building requires a significant amount of replacement and remedial work to plumbing and HVAC systems throughout older portions of the building.

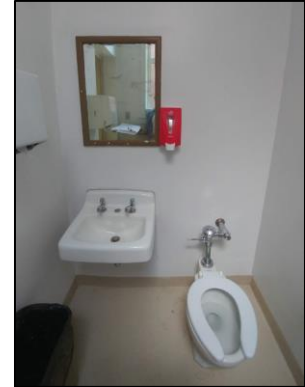
Given the age and configuration of the building, some interior and exterior elements are non-compliant. However, the building has been adapted to provide accessibility to all floors and public areas. Various accessibility issues require correction in order to be fully inclusive. These include items like replacing non-compliant drinking fountains, reconfiguring toilet stalls, modifying casework, and installing undersink insulation or grab bars.

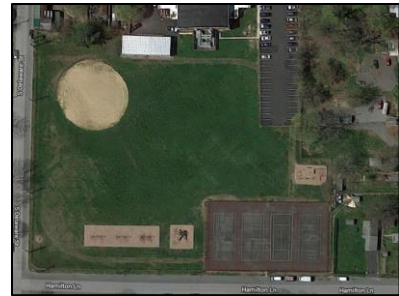
The JBM campus amenities are aged and inadequate for athletics and recreation. Required improvements include renovation and reorganization to provide a new tennis court, soccer field, outdoor basketball court, and playground area.

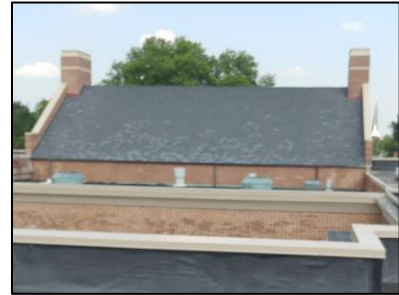
The sloped shingle roof of the Auditorium is in good condition. In the past it was replaced with a long-life synthetic slate shingle, with a service life of 40-50 years. This shows evidence of weathering and repair, but has remaining service life exceeding the timeline of this assessment. This roof requires routine inspection and maintenance, but should serve for the next decade at least.

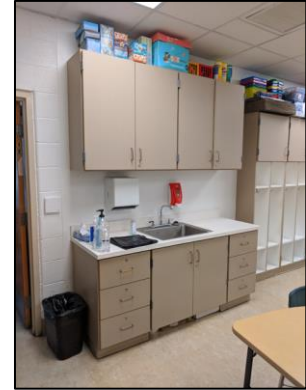
Vertical and horizontal circulation are not significant problems in this 1-story school. Recent modifications have addressed the most critical issues concerning access to restrooms and the stage area. Several remaining toilet rooms require modification or replacement of existing stall configurations. Casework in classrooms, including sinks, are worn and not accessible. These areas should be replaced with new, compliant items. Various other minor accessibility issues require correction in order to be fully inclusive. This includes items like replacing non-compliant drinking fountains, and installing undersink insulation or grab bars.

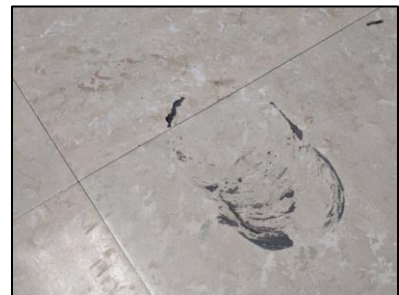
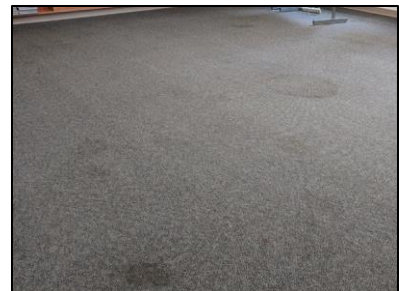
The majority of resilient floor finishes throughout the building are in acceptable condition. Occasional areas of damage or cracking should be corrected. Base trims, however, are worn, damaged, and dated in color (see Walls below for more information). Areas of carpet in Wings A and C-D are worn, stained, and damaged. They are past their expected service life, and should be replaced with new carpet and resilient base trim.

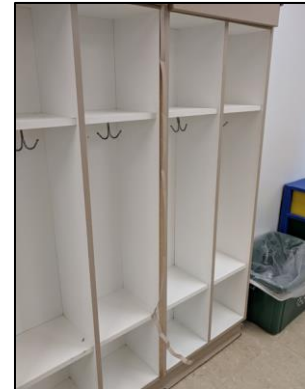
Casework (cabinets, countertops, and shelving) is worn and damaged. Most rooms are still serviceable. Selected areas of damaged casework in Wing A and throughout Wing B should be repaired or replaced in kind. See also Accessibility segment above for non-compliant casework modifications.

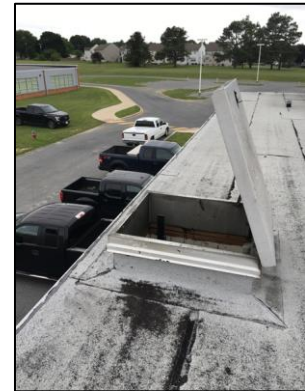
The roof access hatch is located immediately adjacent to the exterior wall and opens directly onto a significant sheer drop. This is a critical safety hazard and is not code compliant. A wall-mounted guard rail must be installed to provide fall protection for personnel using the hatch.

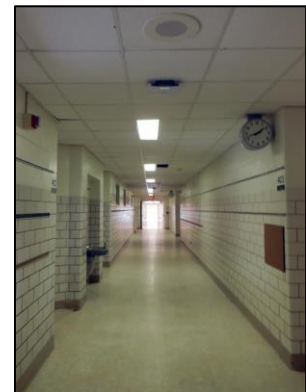
The majority of carpet and resilient floor finishes throughout the building are in good condition. Occasional areas of damage or cracking should be corrected on an as-needed basis.

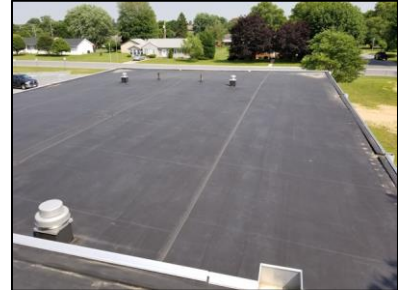
Original built-up or MBR roofs have all been replaced by EPDM membrane roofing systems. All roofs are in new to very good condition, and require only routine maintenance. D Wing roofs are oldest, but should have a remaining service life in excess of the timeframe of this assessment.

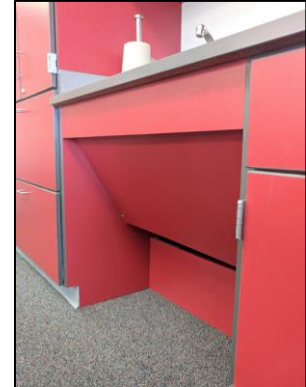
Because this school was built less than 20 years ago, accessibility is fundamentally designed into the facility. However, several items – some minor and some significant – require correction in order to be fully inclusive. Casework at many sinks, although intended to be accessible, is not compliant and does not offer proper clearance.

These should be modified and / or replaced with new, compliant items. Various other minor accessibility issues include items like replacing toilet accessories and installing undersink insulation or grab bars.

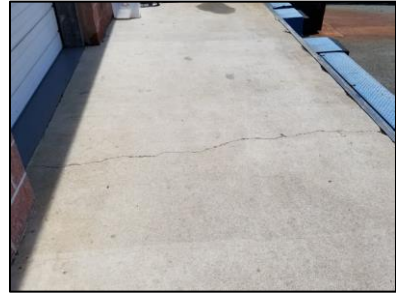
SMS.111

Existing concrete walk areas are in generally good condition. Regular maintenance with replacement of individual sections as necessary will keep them in service. Cracks in the loading dock area concrete require correction in the near future to prevent further deterioration.

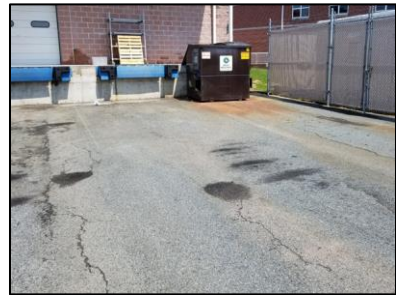
SMS.112

Asphalt paving around the site is in good condition. Paving has failed in the loading dock area due to excessive weight and duty cycle. Remove the existing asphalt in this area and replace with a concrete apron designed for the traffic load.

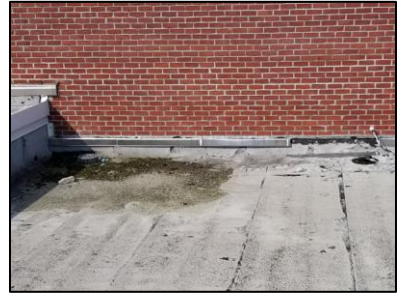
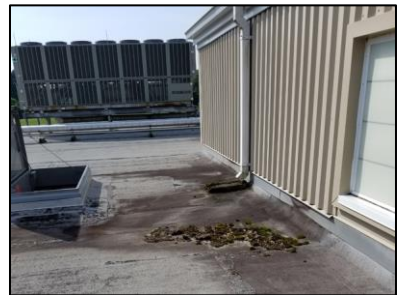
SMS.112, SMS.133

Original modified bitumen roof (MBR) systems date from 2002-2006. Low slope membrane roofs are still within their expected service life, but will require replacement in the long-term future. In the meantime, they require routine maintenance and localized areas of repair. Soft / wet spots and areas of ponding should be cut out (including insulation) and replaced in kind. Loose or missing flashings should be replaced.

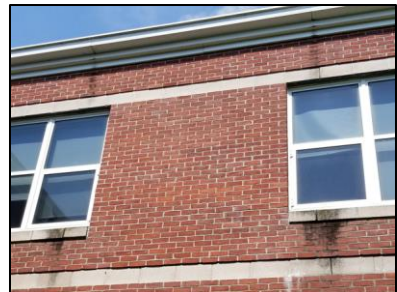
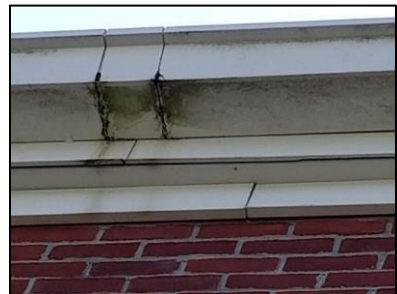
SMS.102

Aluminum gutters around the entire building perimeter are leaking at joints and seams. Water overflow stains walls, creates infiltration issues, splashes mud on lower walls, and erodes turf and grade.

Gutters and downspouts require a comprehensive re-sealing program to eliminate these symptoms and remove the underlying source of water.

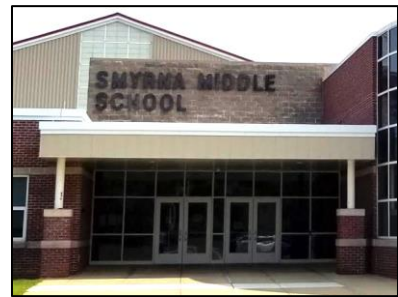
SMS.140

The building is relatively secure thanks to operational policy and existing systems. There are no immediate needs for additional measures. In the moderate future term, the District should consider additional protective measures such as ballistic window film or other hardpoint retrofits.

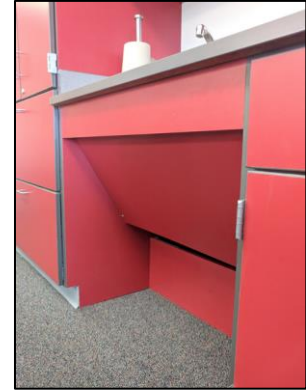
SHS.56

Most accessibility issues have been remediated as part of renovations and ongoing upgrades. A few unrenovated areas require modifications to toilet rooms. Various other minor accessibility issues include items like replacing toilet accessories and installing undersink insulation or grab bars. Remaining non-lever door hardware is recommended to be updated as part of a door replacement project as outlined below.

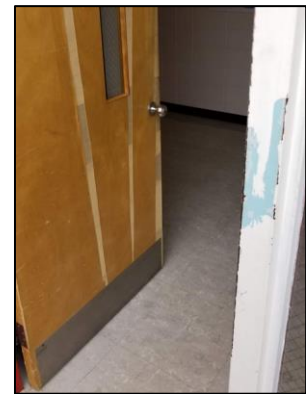
SHS.45, SHS.46, SHS.47, SHS.48, SHS.49, SHS.62, SHS.66, SHS.73

Most interior doors (solid core wood veneer, stained) and frames (hollow metal, painted) show minor wear and tear, but are in good condition. Doors and frames in high-traffic areas should be refinished as part of an ongoing interior painting program. Worn / damaged doors, frames, and / or hardware should be replaced in unrenovated areas (areas D, E, F, and G) to bring them up to par with the balance of the school. This will also eliminate most remaining knob locksets, to be replaced with ADA-compliant lever handles.

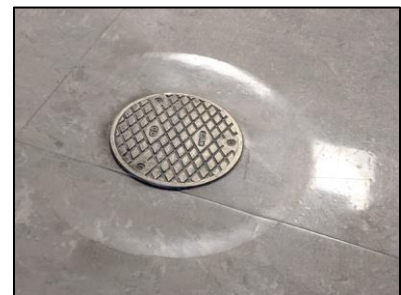
SHS.05, SHS.18, SHS.33, SHS.36, SHS.63, SHS.97, SHS.98

The majority of resilient floor finishes throughout the building are in good to serviceable condition. Occasional areas of damage, cracking, or uneven surfaces should be corrected, including patching of concrete substrates where required. Core area terrazzo floors are in good condition, with localized cracking that requires correction.

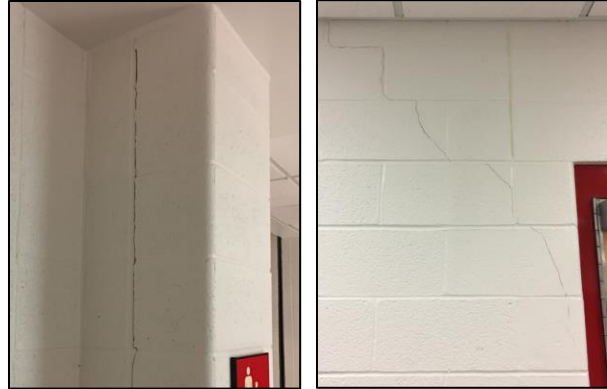
SHS.06, SHS.22, SHS.54, SHS.70, SHS.71, SHS.80, SHS.81, SHS.90, SHS.91, SHS.92, SHS.93, SHS.94, SHS.95, SHS.99, SHS.100, SHS.101

Interior walls are a mix of painted gypsum wallboard and painted masonry. Interior classroom and support area walls are typically gypsum wallboard with paint or areas of ceramic tile. Most walls in high-traffic or heavy duty areas, including corridors, toilet rooms, core amenities, and inside face of exterior walls are painted masonry. Interior walls are in good to fair condition. Select areas should be repainted, including incidental patching as required. Masonry walls and partitions show significant cracking in localized areas, which requires repair and repainting. This work is outside the scope of typical incidental touch-up by district personnel.

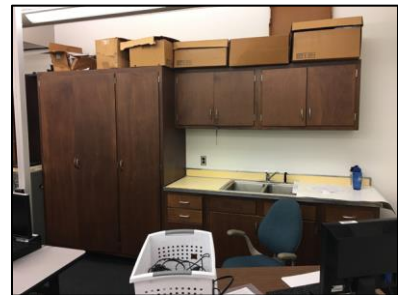
SHS.55

Casework (cabinets, countertops, and shelving) in renovated areas is in good condition and accessible, with only minor maintenance required. However, casework in unrenovated areas (areas D and E) is original to the building. These fixtures are well past their expected life span, show substantial wear and damage, and are not accessible. Casework in remaining unrenovated rooms should be replaced with new suite of fixtures to match renovated areas.

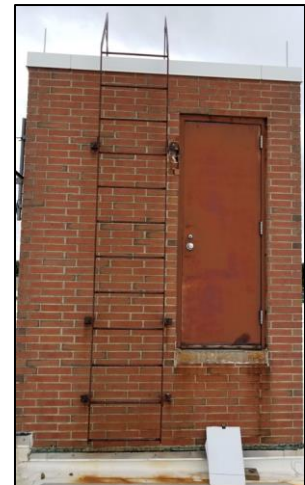
Exterior brick / CMU walls are in overall good condition, but show localized cracking or weathering. Cracks require repair and limited repointing. Some wall / roof joint flashings require minor repairs.

The chimney at Roof Area 2 is in poor to bad condition. The existing door and frame are deteriorated and should be filled in. This chimney is minimally used since major mechanical equipment was relocated to the new Central Plant. The District should consider demolishing it in the future to eliminate ongoing maintenance.

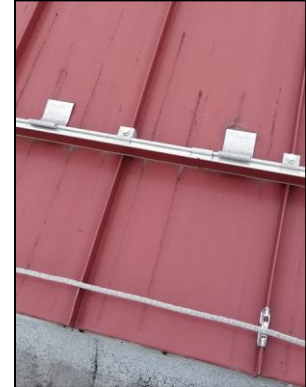
Standing seam metal roofs are typically in good condition throughout the building. Ice / snow guards are present and functional.

Metal roofing at the main front and rear additions (R1 and R21 – 2008) is showing unexpected corrosion. The cause is unknown at this time, but the material should be within the specified product finish warranty. It is recommended that the District contact the contractor and manufacturer to begin the investigation / claim process

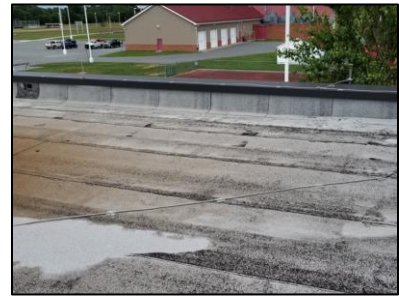
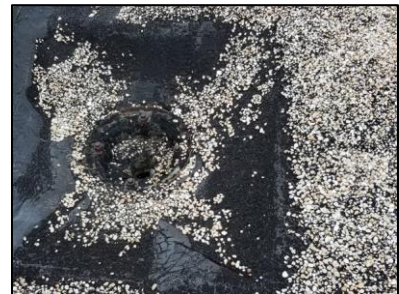
SHS.118, SHS.120, SHS.121, SHS.122, SHS.125, SHS.126, SHS.127, SHS.128

Due to the nature of the building and various expansions throughout history, the low-slope roofs are broken up into numerous areas. Many of these have been replaced with new EPDM or TPO membrane in the moderate past, and have plenty of service life left with typical routine maintenance.

Remaining modified bitumen roof (MBR) and gravel-ballasted built-up roof (BUR) systems are well past expected service lives, and require replacement. Priority varies from immediate to moderate future depending upon the condition of each area. In the meantime, they need routine maintenance and localized areas of repair.

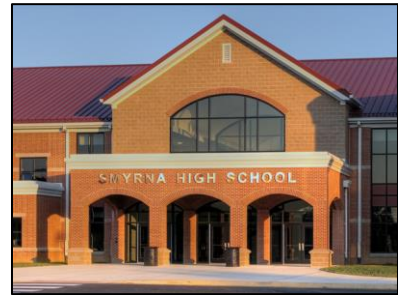
SHS.142, SHS.143

The building is relatively secure thanks to operational policy and existing systems, but the aging security network requires immediate upgrades and additional cameras in both interior and exterior areas. In the moderate future term, the District should consider additional protective measures such as ballistic window film or other hardpoint retrofits.

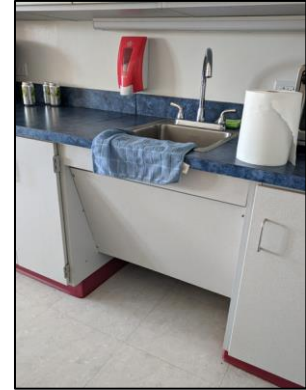
SSE.01

Built in the last 10 years, the building is fundamentally accessible throughout. Casework at some classroom and workroom sinks, though designed to be accessible, are not fully compliant. In the long term, these should be corrected for full inclusiveness.

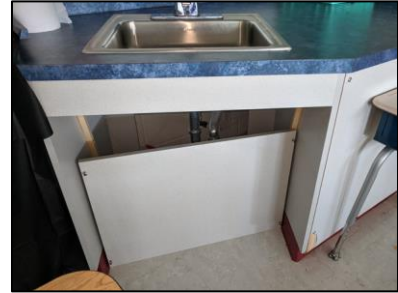
SSE.07, SSE.20, SSE.27

Casework (cabinets, countertops, and shelving) is in good condition and typically accessible, with only minor maintenance required. See also Accessibility heading above for clearance issues at sinks.

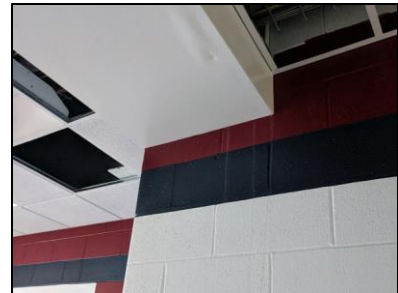
Ceilings are predominantly lay-in acoustical panel suspended grid systems, with areas of painted gypsum wallboard or exposed structure. Most are in good condition, but localized areas throughout the building show evidence of water infiltration or leaks. These must be investigated by District personnel, the water sources corrected as required, and damaged materials replaced.

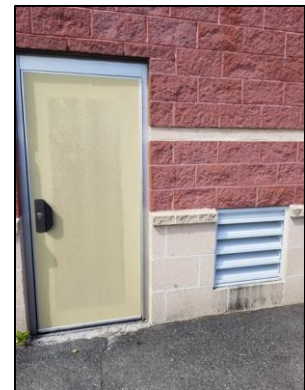
Exterior hollow metal doors, frames, and hardware are in generally very good condition, but finishes are beginning to weather. Selected exterior hollow metal doors and frames should be painted in the near future to protect against rust.

Aluminum storefront entrances are in very good condition, and require only routine maintenance for the foreseeable future.

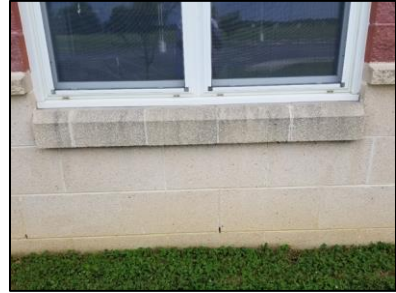
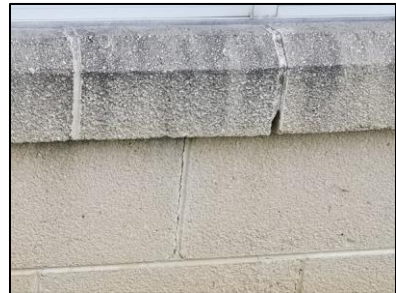
SSE.38, SSE.39

Exterior brick / CMU walls are in overall good condition, but show localized cracking or weathering, particularly around stone window sills. Cracks require repair and significant repointing. Cracked masonry units must be cut out and replaced in kind.

The building shows dirt staining on split face masonry walls. As part of the repair / repointing project, washing all exterior walls will maintain appearance and prevent permanent staining.

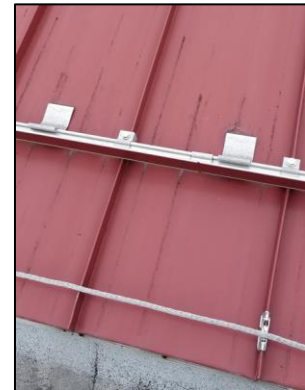
Metal roofing at the main front and rear additions (R1 and R21 – 2008) is showing unexpected corrosion. The cause is unknown at this time, but the material should be within the specified product finish warranty. It is recommended that the District contact the contractor and manufacturer to begin the investigation / claim process

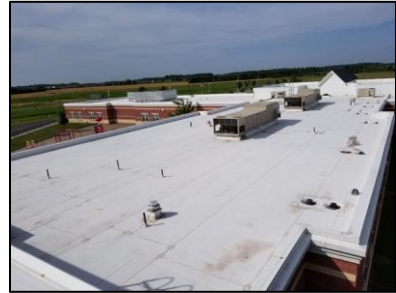
At 10 years old, original EPDM membrane roofing systems are approximately halfway through their expected service life. All roofs are in very good to good condition, and require only routine maintenance to remain in service beyond the timeframe of this assessment.

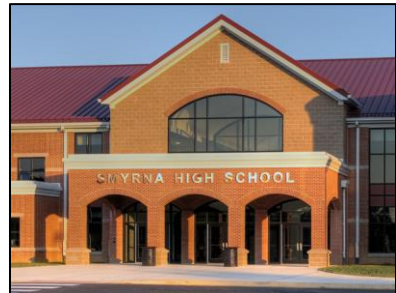
SSE.53

The building is relatively secure thanks to operational policy and existing systems, and does not have any immediate need for additional measures. In the moderate future term, the District should consider adding protective measures such as ballistic window film or other hardpoint retrofits.
